Massachusetts Department of Environmental Protection
Bureau of Resource Protection – Watershed Permitting Program
Sanitary Sewer Overflow (SSO)/Bypass
Notification Form

Hull WPCF
Reporting Sewer Authority

Location: 14 VAUTRINT AVE
(Description of discharge site or closest address)

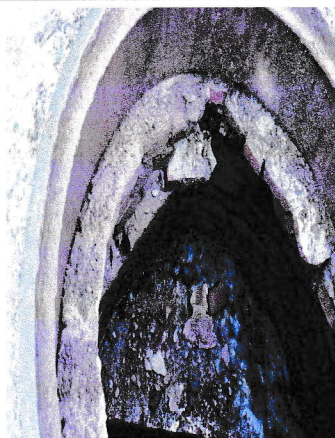
Service: Inspect manholes and camera used. Could not snake through from upstream manhole. Got to within 25 feet of leak snaking camera upstream. Upstream manhole of leak had a lot of debris and evidence of manhole deterioration. Report findings to PSC.

Upstream manhole

Inspect upstream + downstream manholes; Attempt to CAMERA line from both sides of blockage. Vactor/Jet truck called in + clean manhole + attempt to jet lines. Freed up enough to stop leakage (6/10). Sewer line marked for estimated area of blockage.

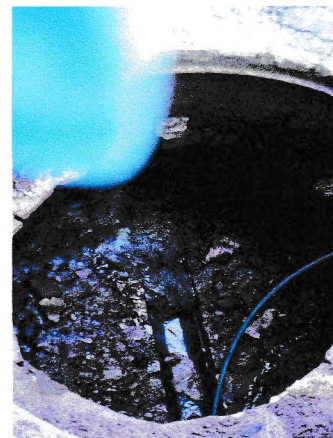
IN conclusion; leak caused by brick in SEWER main. SEWAGE BACKED UP + WAS leaking out of a clay pipe joint.

Blockage in upstream manhole

SEWER MAIN REPAIR FOR uniform 6" piping.

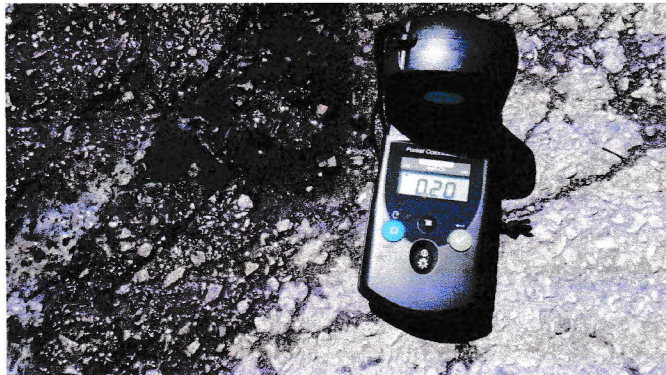
Action Notes(1): Chlorine test of water

Picture Description(1): Result of chlorine test
